MERRITT &amp; HARRIS, INC.

20-251E

Re: **World Trade Center**  
**New York, New York**

One World Trade Center

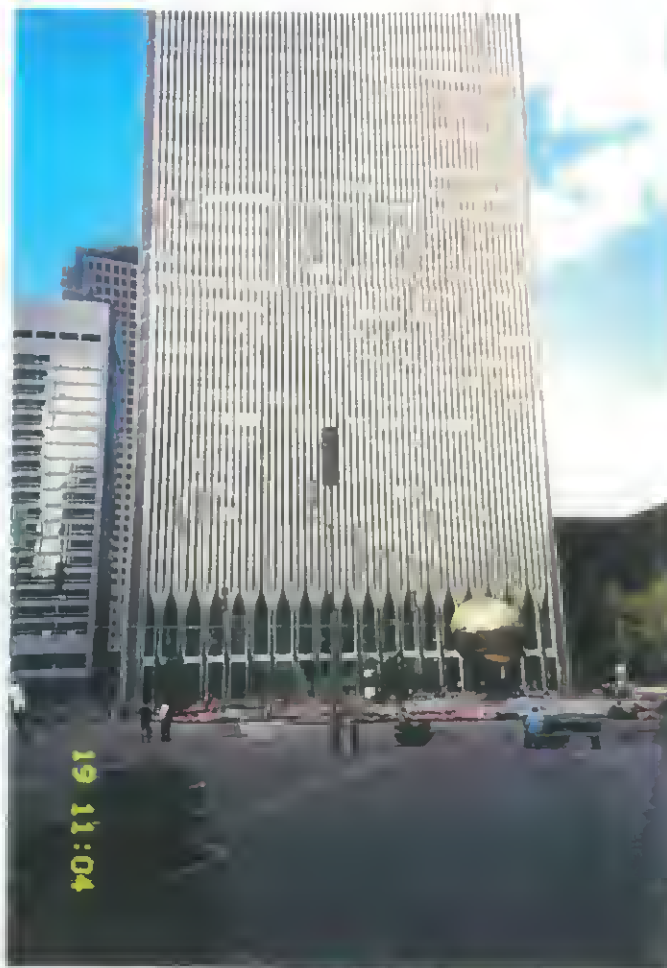
Photograph 1

Front plaza level  
entrance (east)

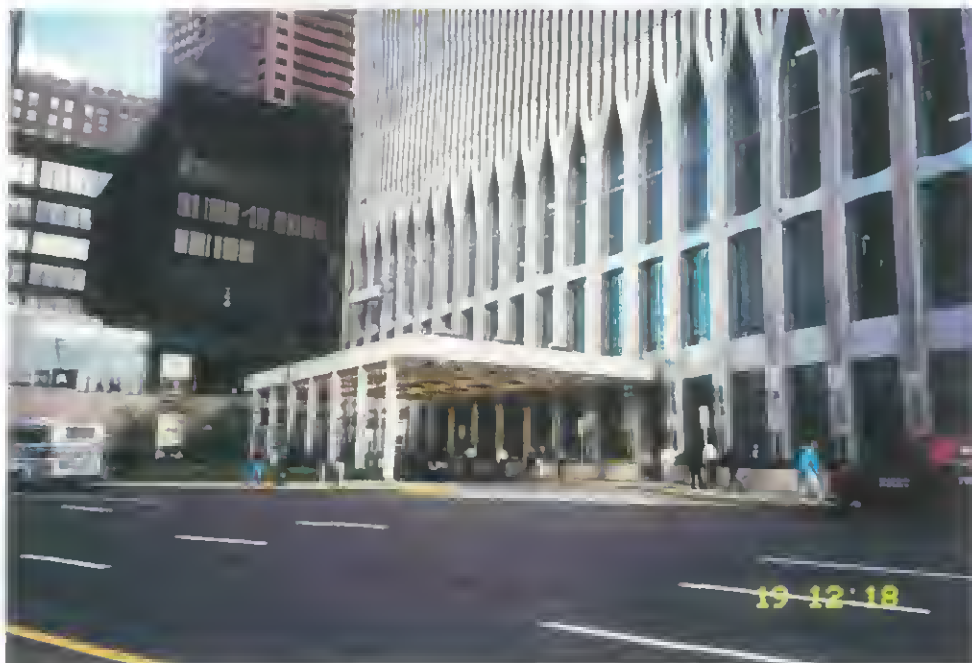
Photograph 2

West Street Entrance  
to Lobby

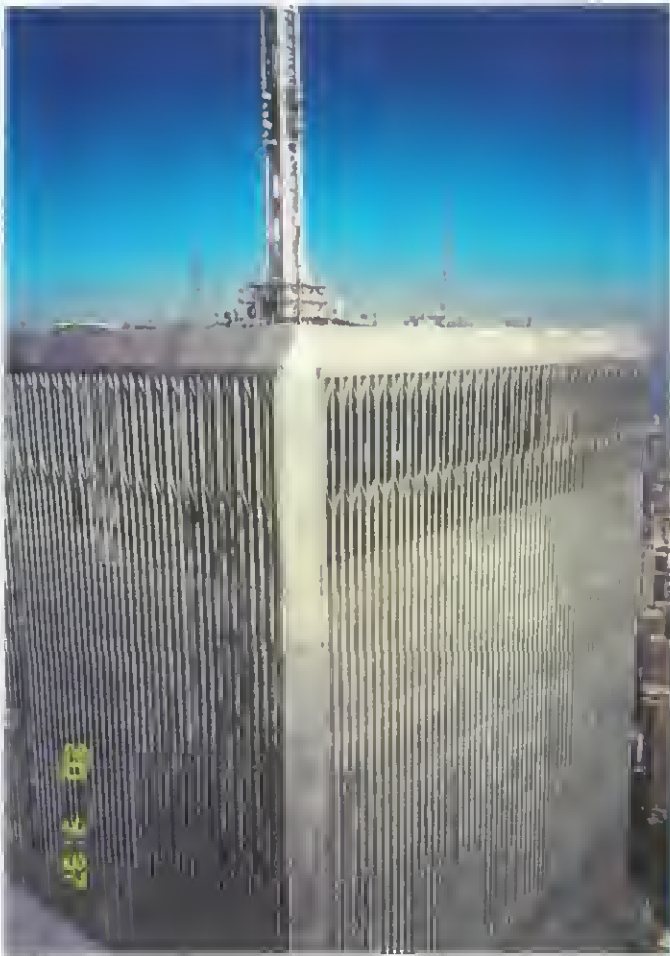
Photograph 3

Rooftop and antenna

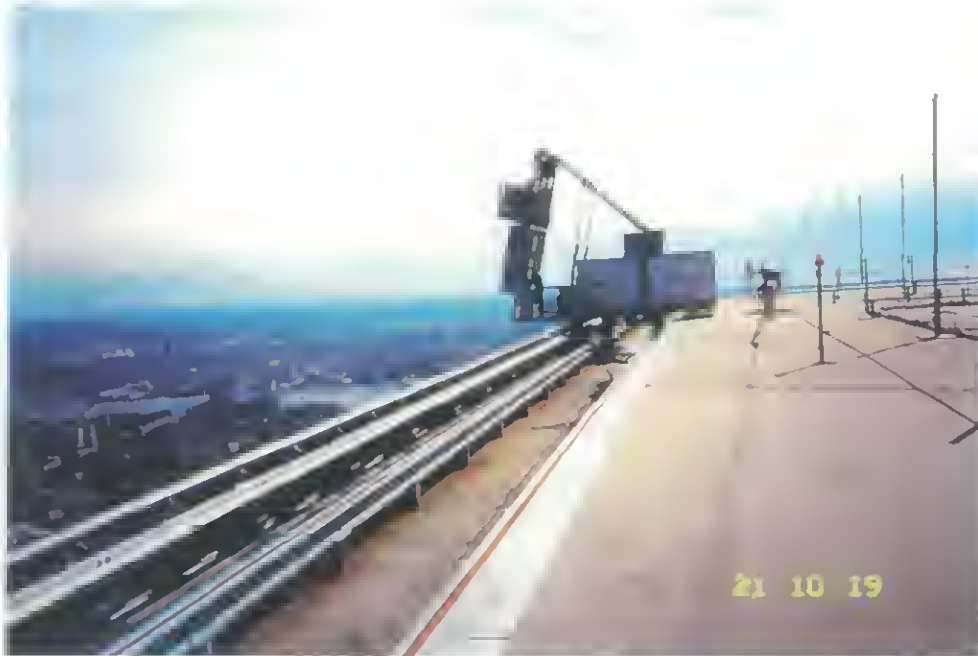
**Photograph 5**

Window washing rig

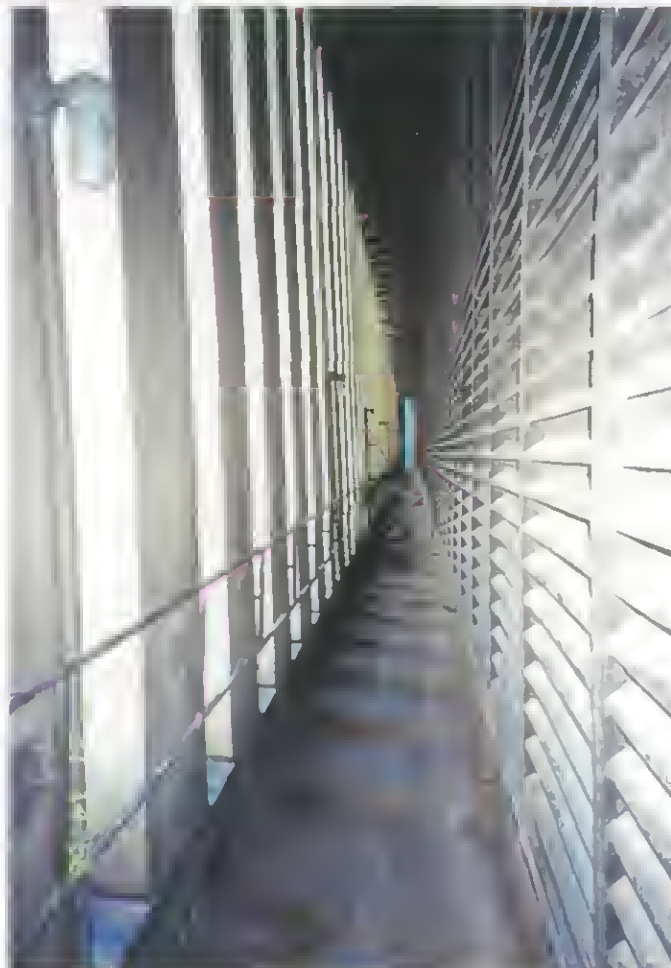
**Photograph 6**

Typical setback at  
MER levels

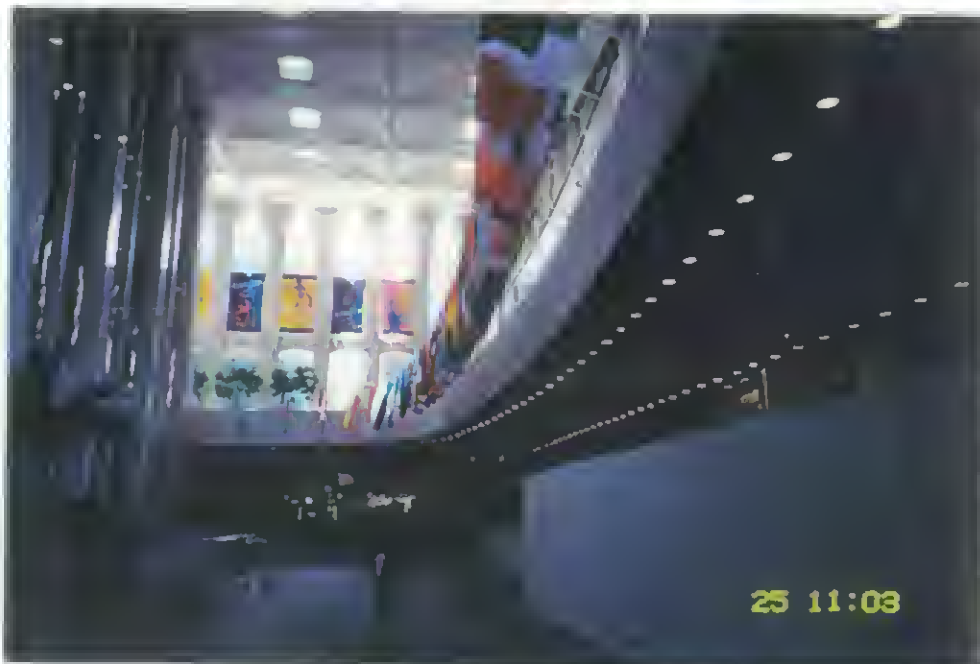
Photograph 7

Lobby with plaza  
level mezzanine  
above

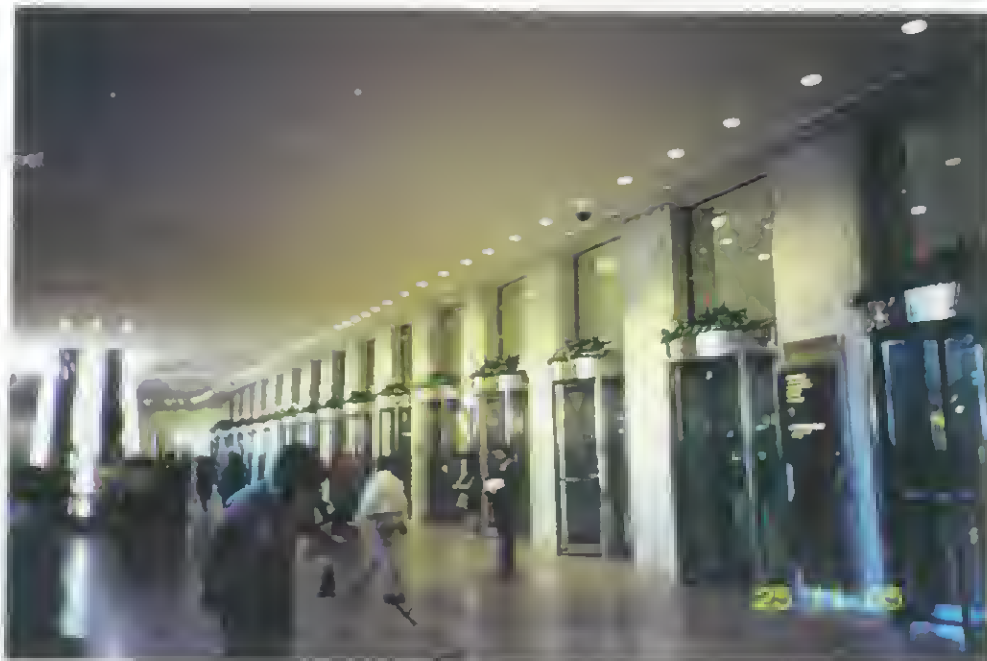
Photograph 9

Lobby entrance  
from mall, and  
escalators to  
mezzanine

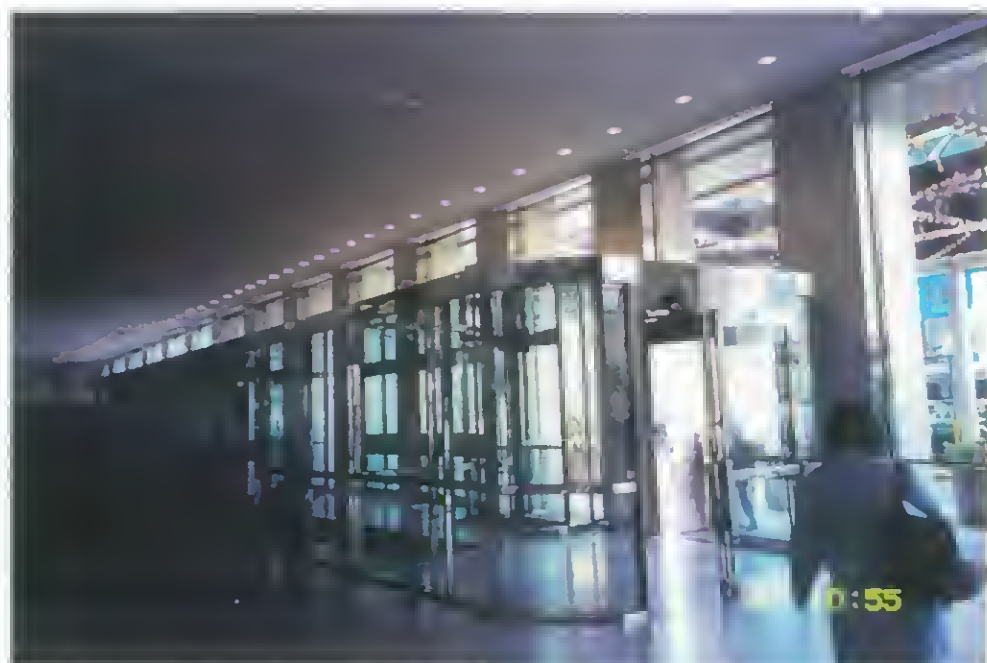
Photograph 10

Lobby entrance and  
vestibule on West  
Street

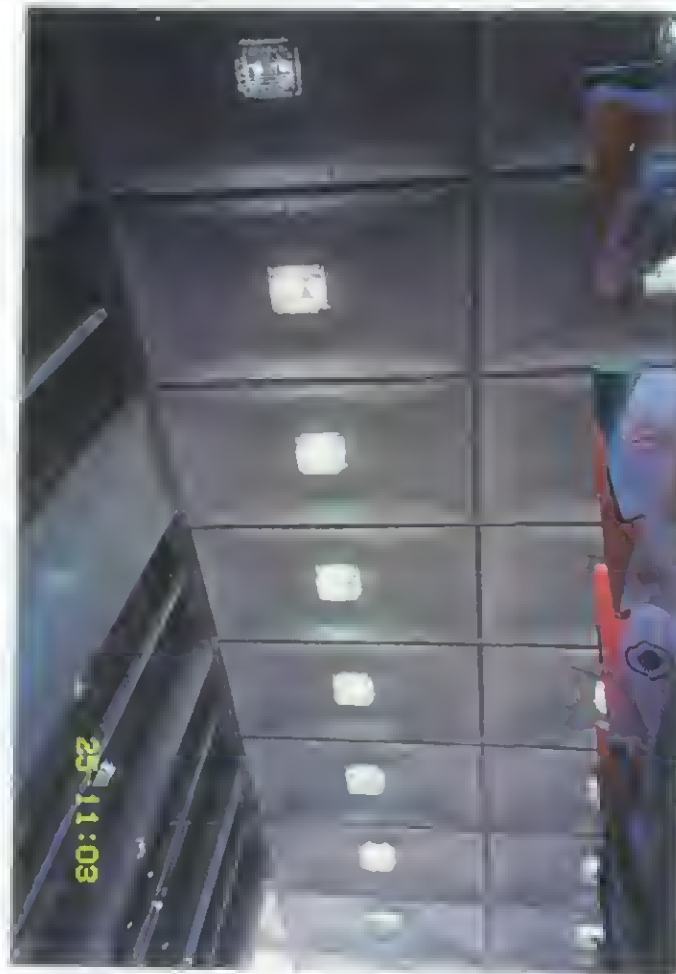
**Photograph 11**

Lobby suspended  
plaster ceiling panels

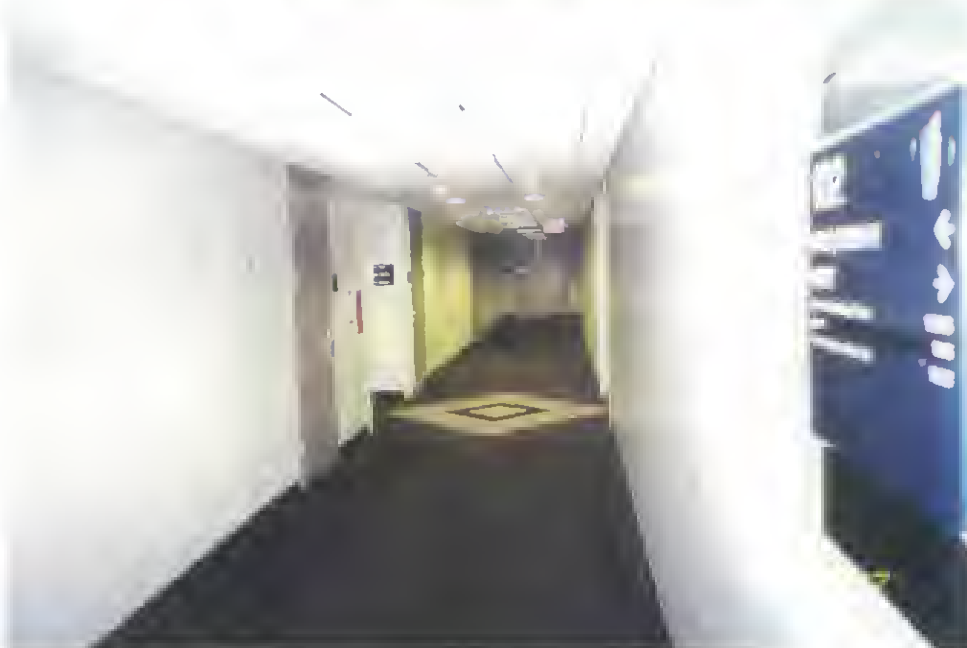
**Photograph 12**

Typical multi-  
tenanted floor  
corridor

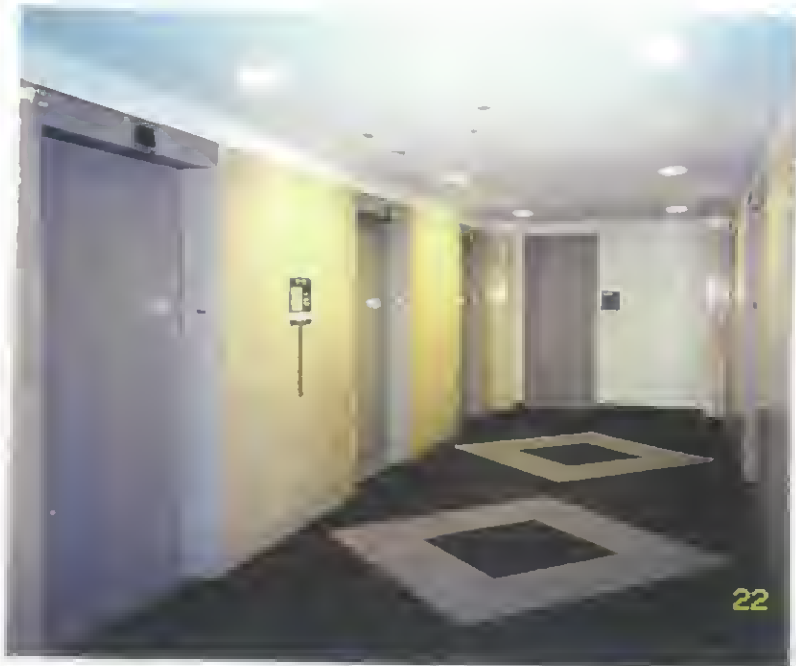
Photograph 13

Typical multi-  
tenanted floor  
elevator vestibule

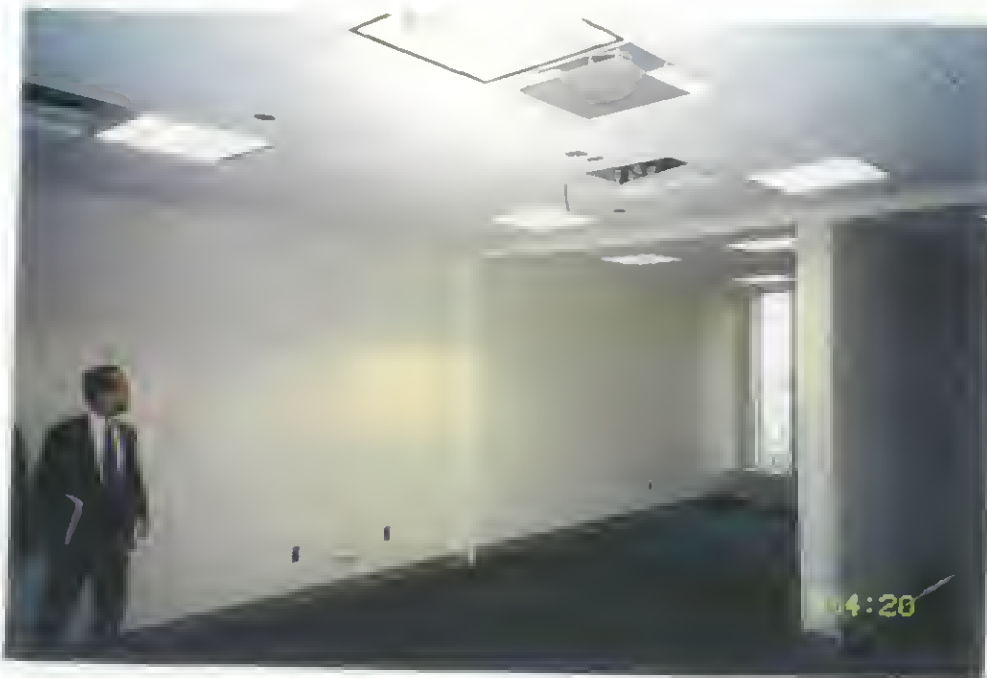
Photograph 15

Vacant space

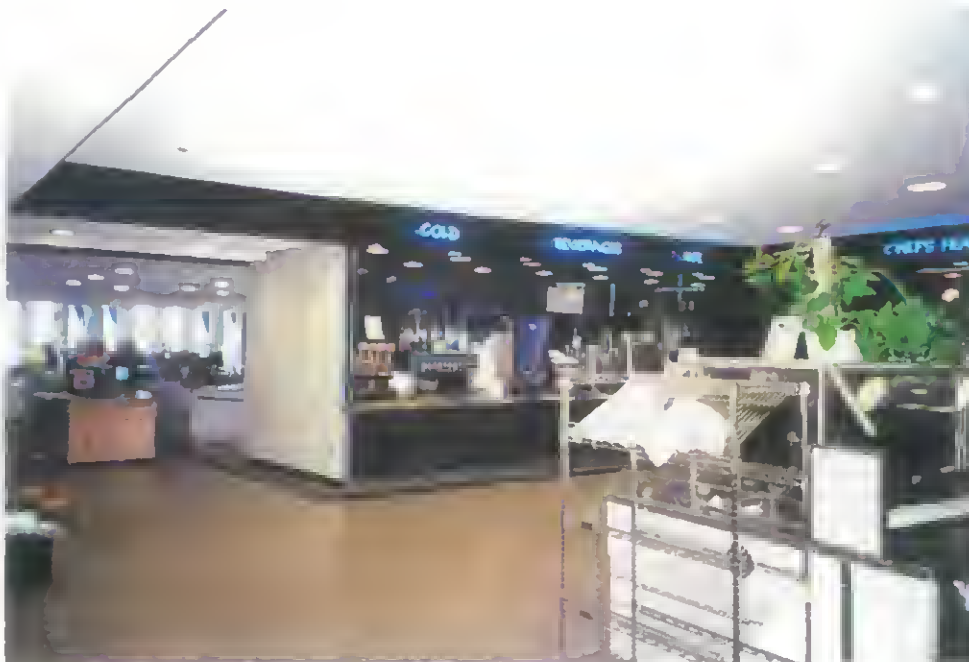
Photograph 18

Port Authority  
Cafeteria on 43rd  
floor

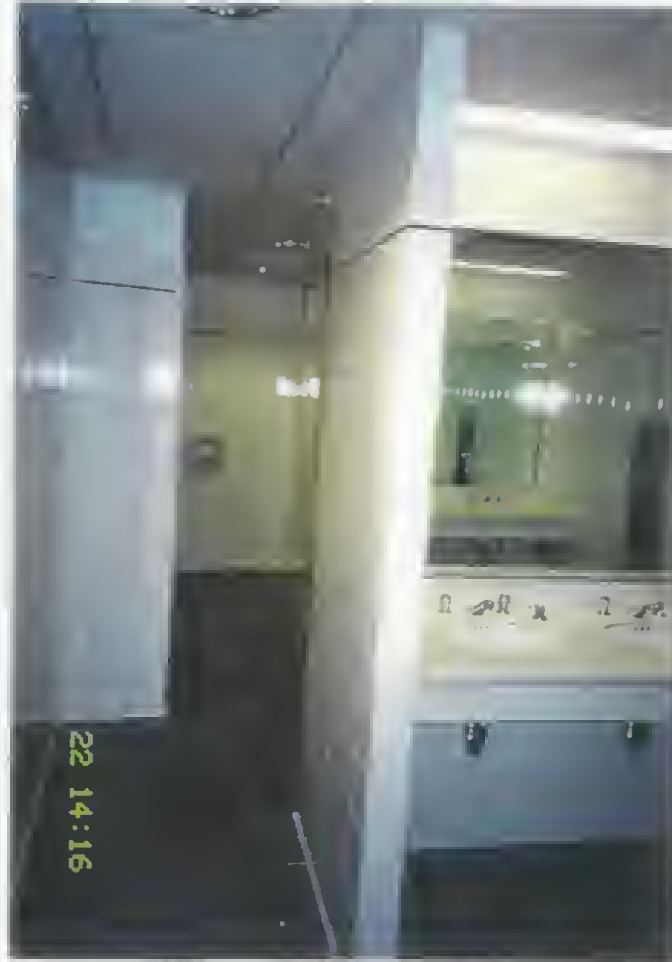
Photograph 20

Elevator vestibule  
Level B3 for garage

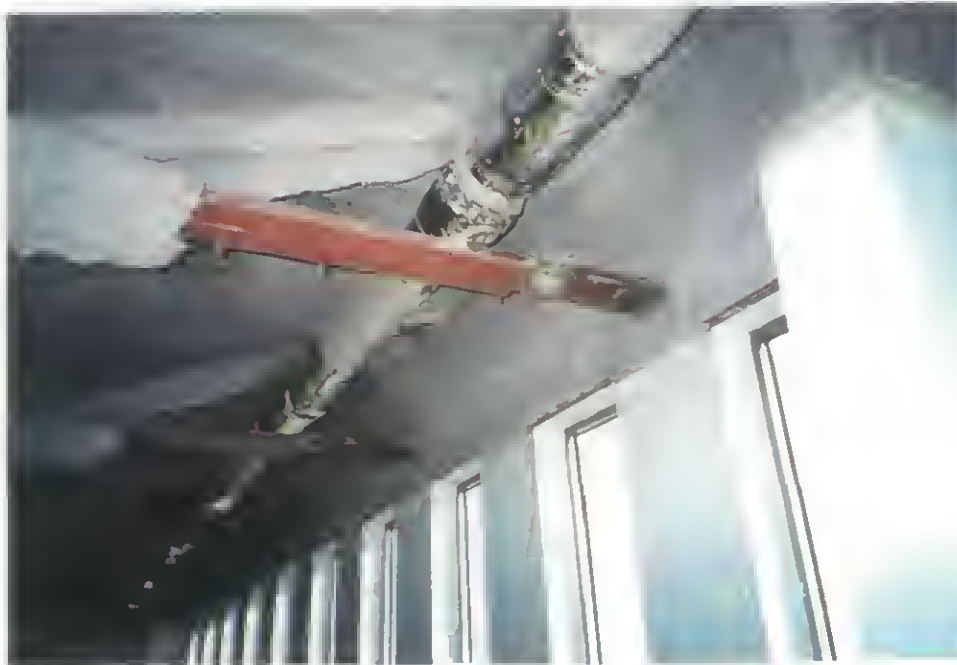
Photograph 22

Viscoelastic damper  
at each floor joist.

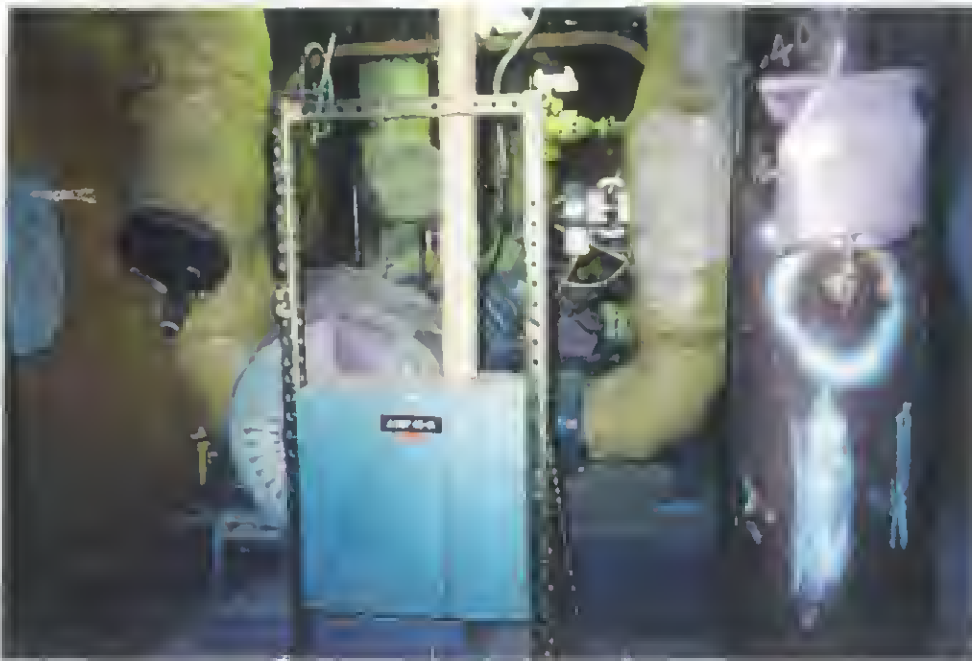
Photograph M1

Condenser water  
system #2 pump

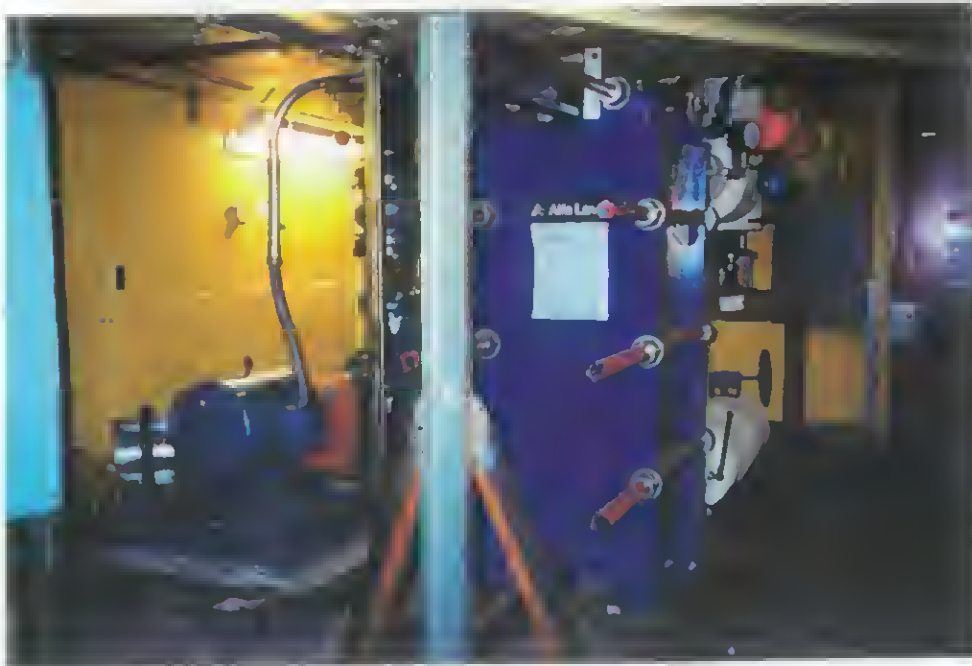
**Photograph M3**

New condenser  
water system #2  
pump and plate  
and frame heat  
exchanger

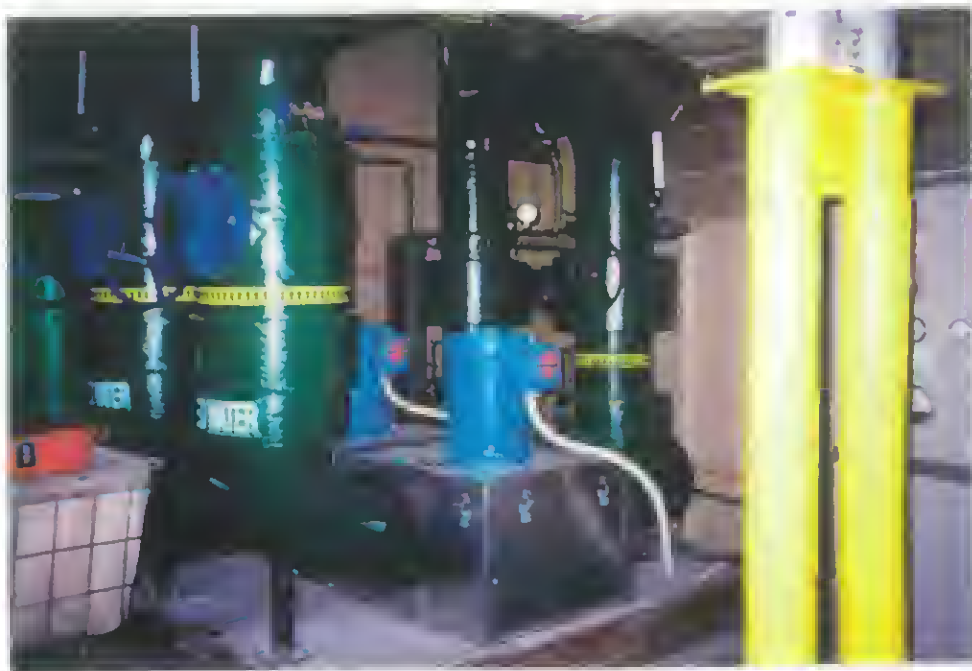
**Photograph M4**

New freeze  
protection  
system chilled  
water pumps

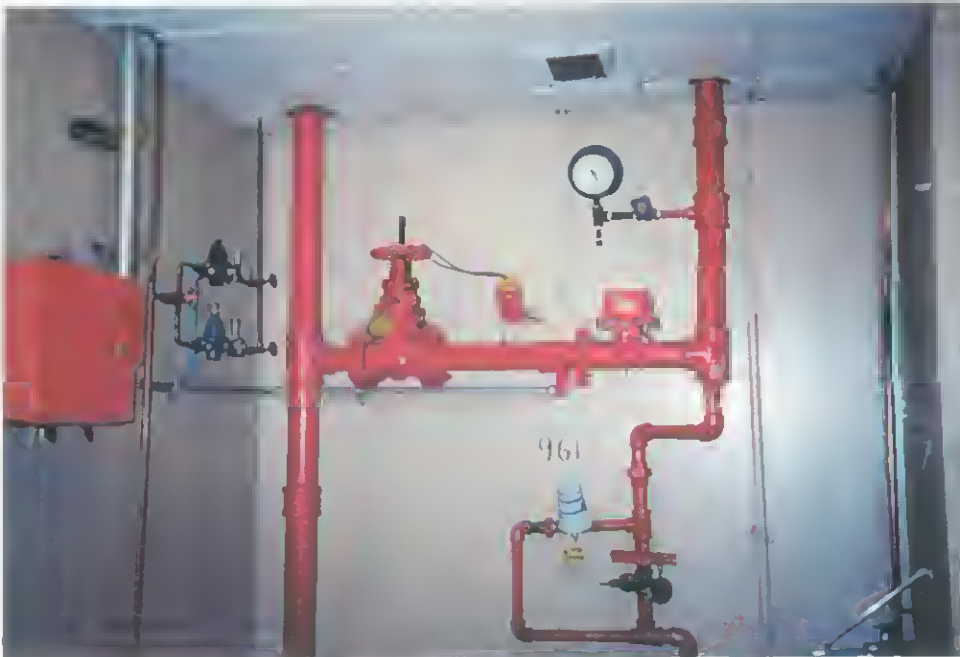
**Photograph M7**

Typical floor  
sprinkler control  
valve room with  
sprinkler supply  
line and flow and  
tamper switches

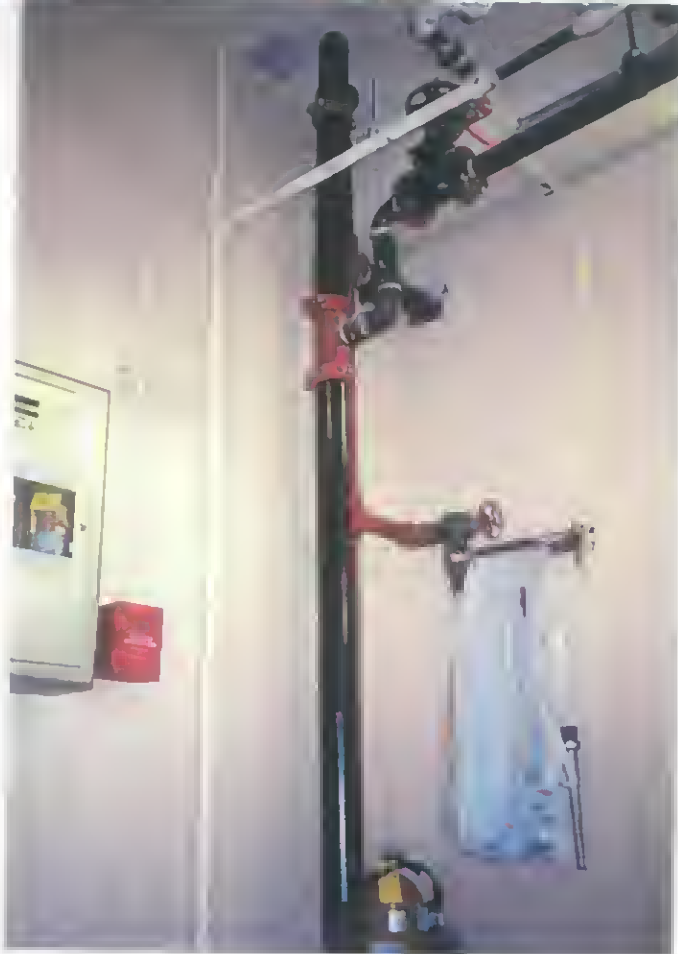
**Photograph M8**

Standpipe riser  
with a fire hose  
rack, and fire  
extinguisher  
cabinet located  
in the stairs

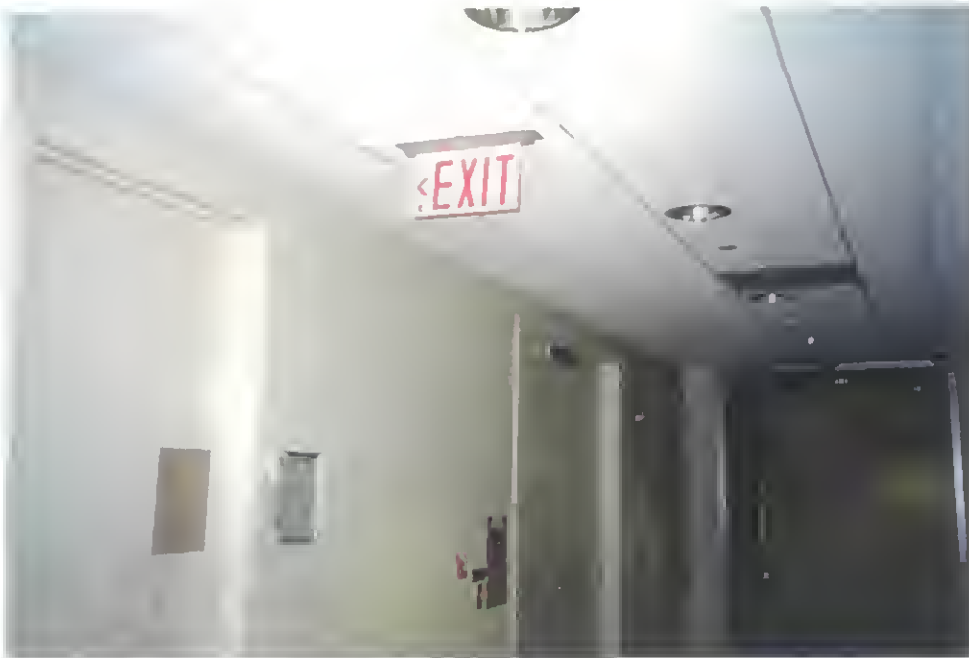
PhotographM9

Typical office  
floor corridor  
with an exit sign,  
manual pull  
station, fire  
warden station,  
and audio/visual  
alarm

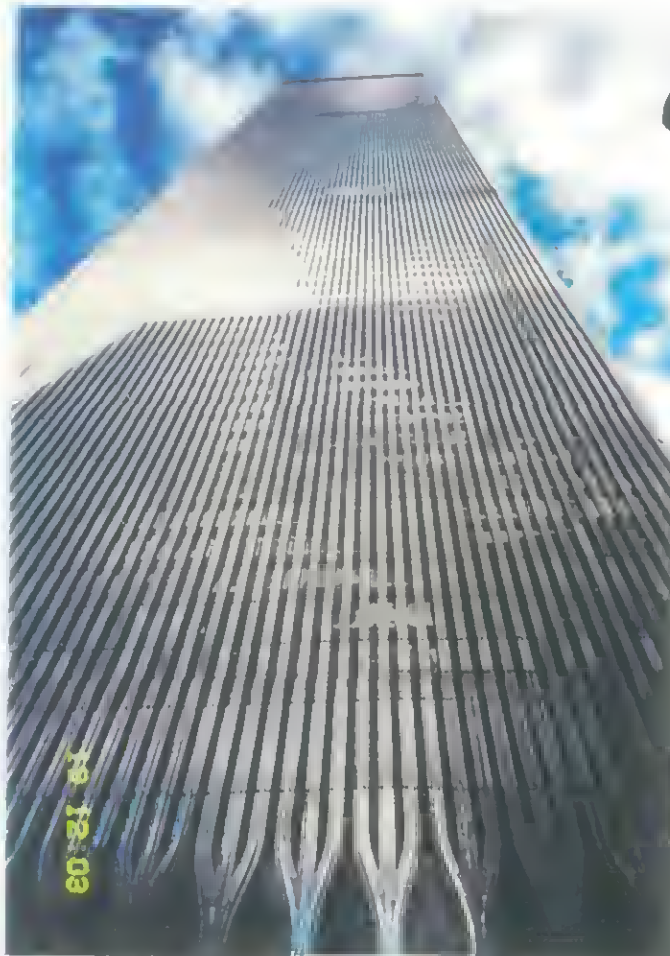
Photograph 1

Liberty Street  
elevation

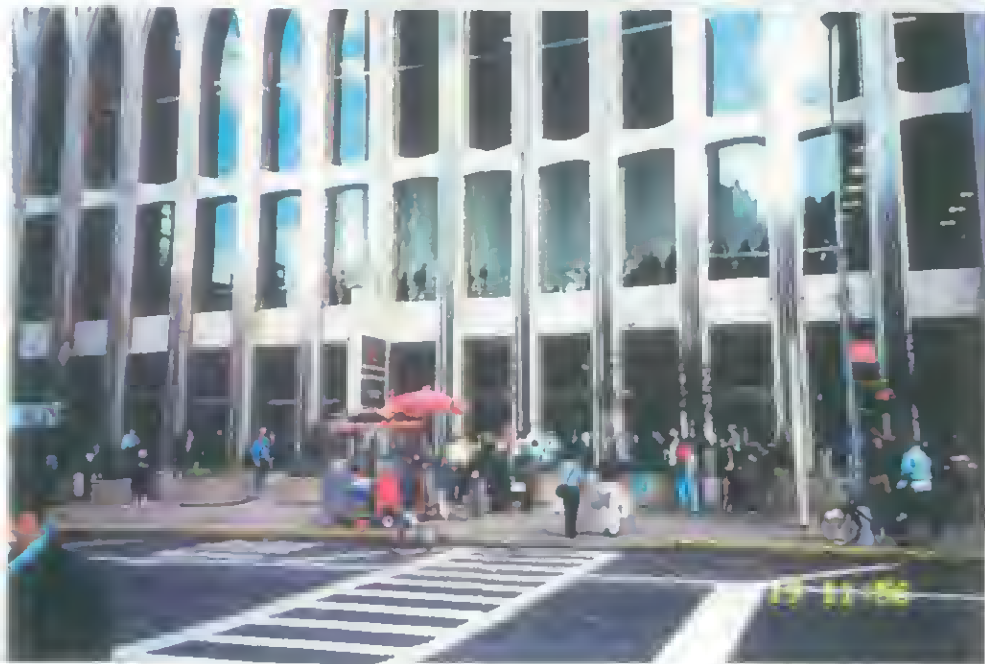
Photograph 2

Liberty Street  
entrance to Lobby

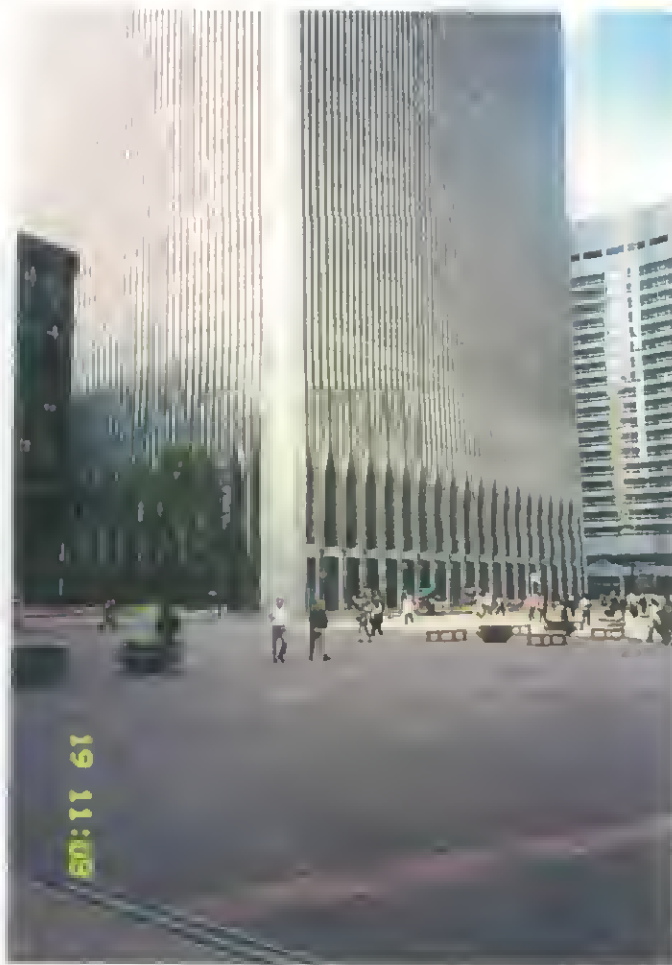
Photograph 3

Plaza elevation,  
Marriott hotel in  
background

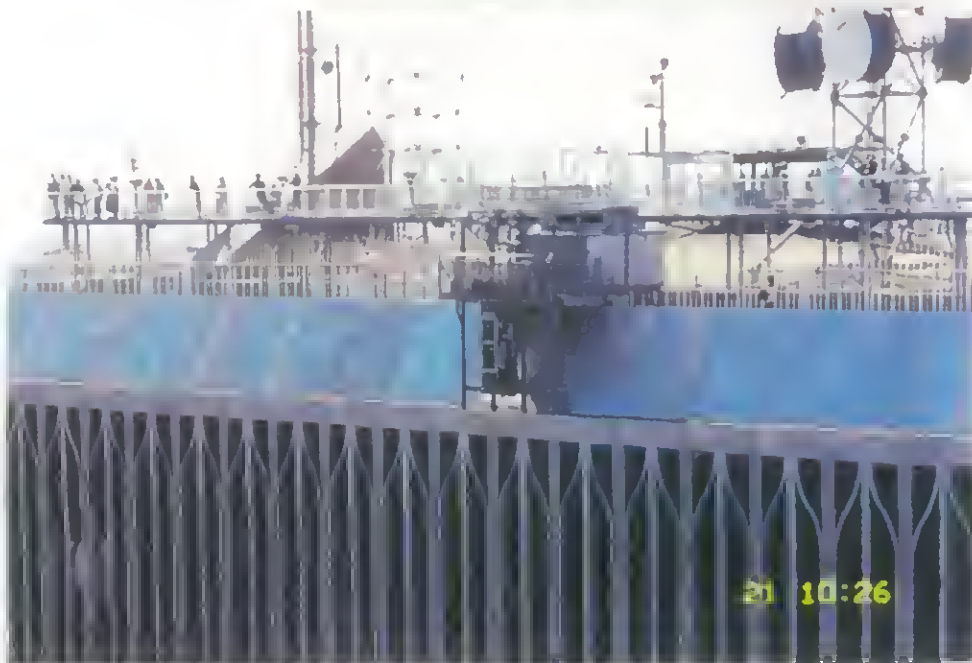
Photograph 4

Rooftop observation  
deck, window  
washing rig

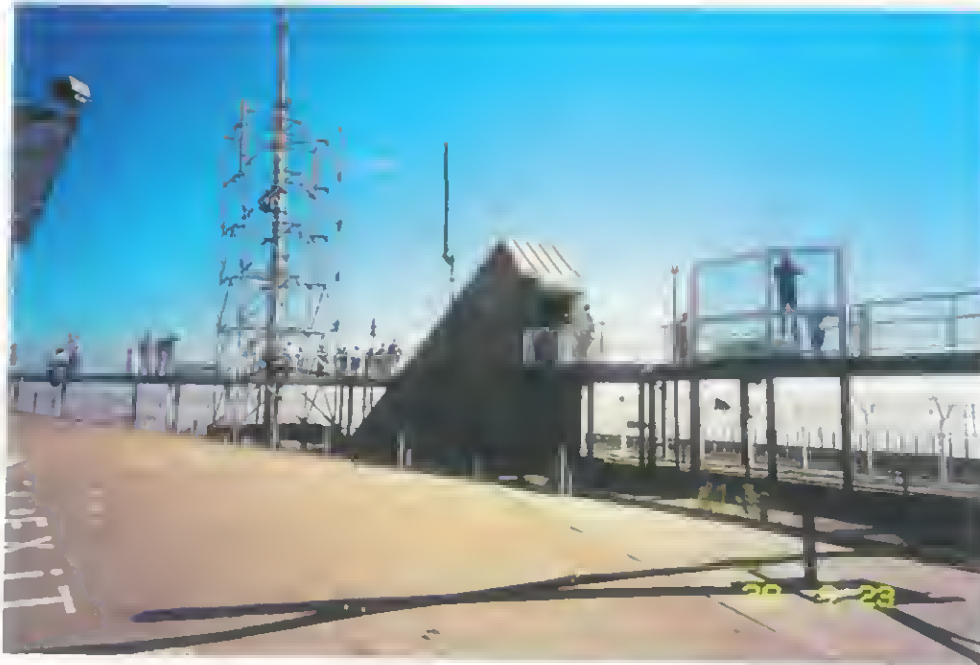
Photograph 5

Entrance to rooftop  
observation deck;  
note concrete  
covered roof

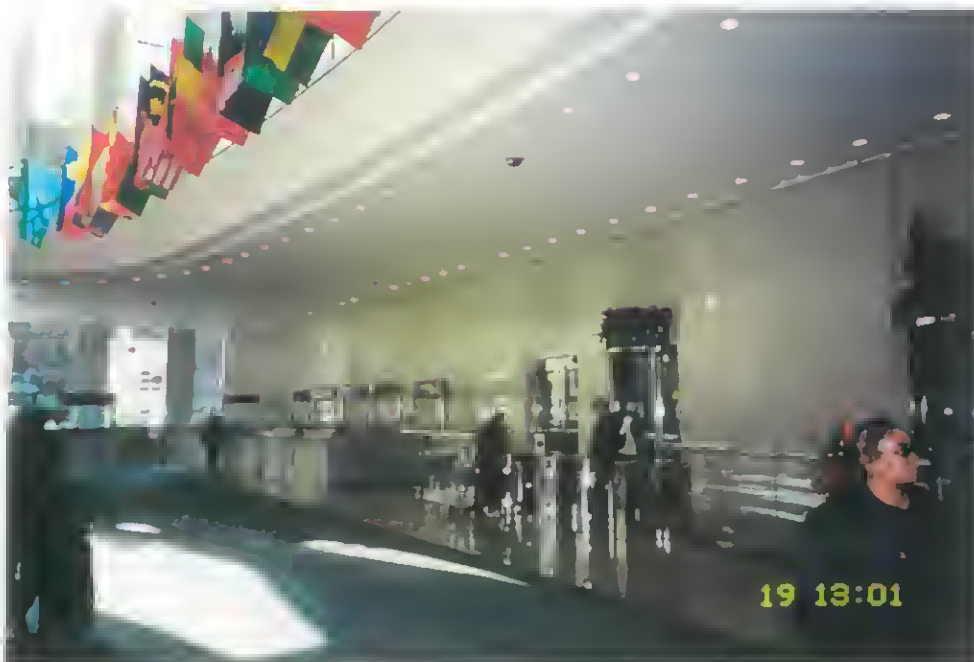
Photograph 12

Lobby, secured  
entrance to elevators  
to garage on right

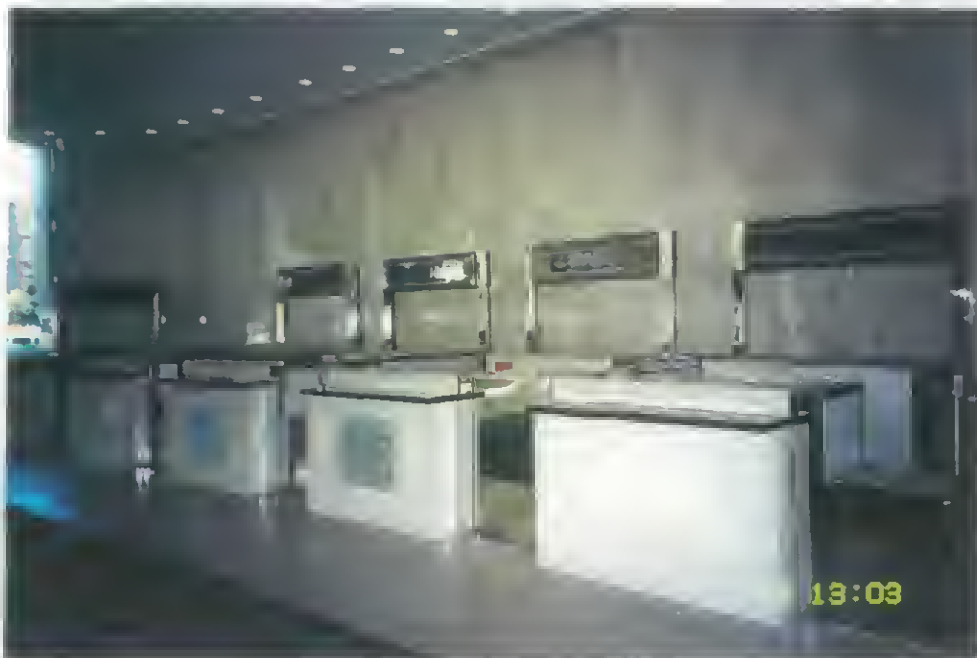
Photograph 13

Vacated desks in  
lobby

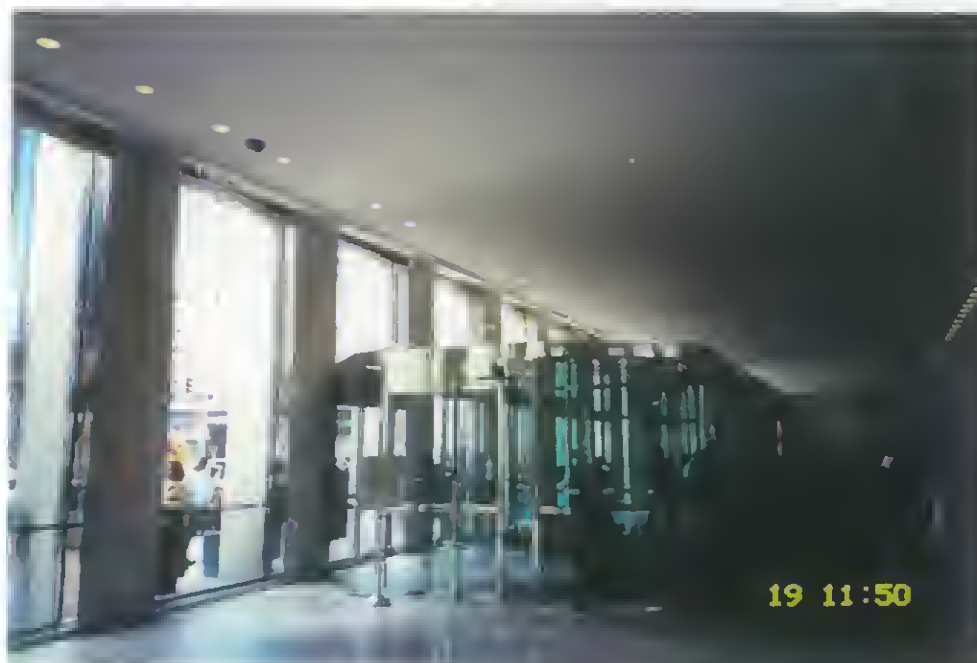
Photograph 14

Lobby and vestibule  
entrance from  
Liberty Street

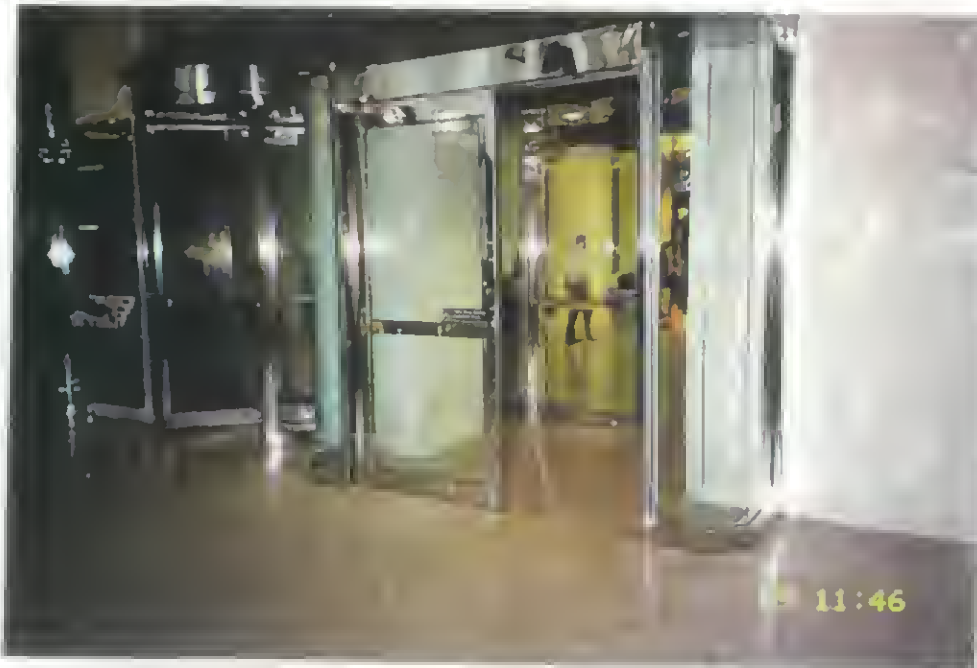
Photograph 15

ADA accessible  
entrance from mall

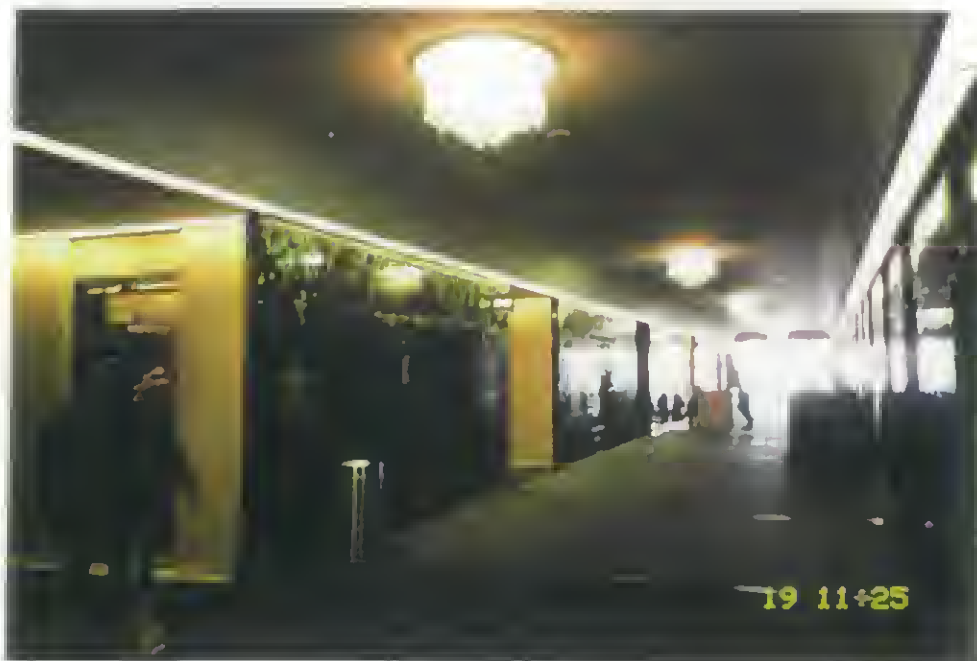
Photograph 16

Typical sky lobby

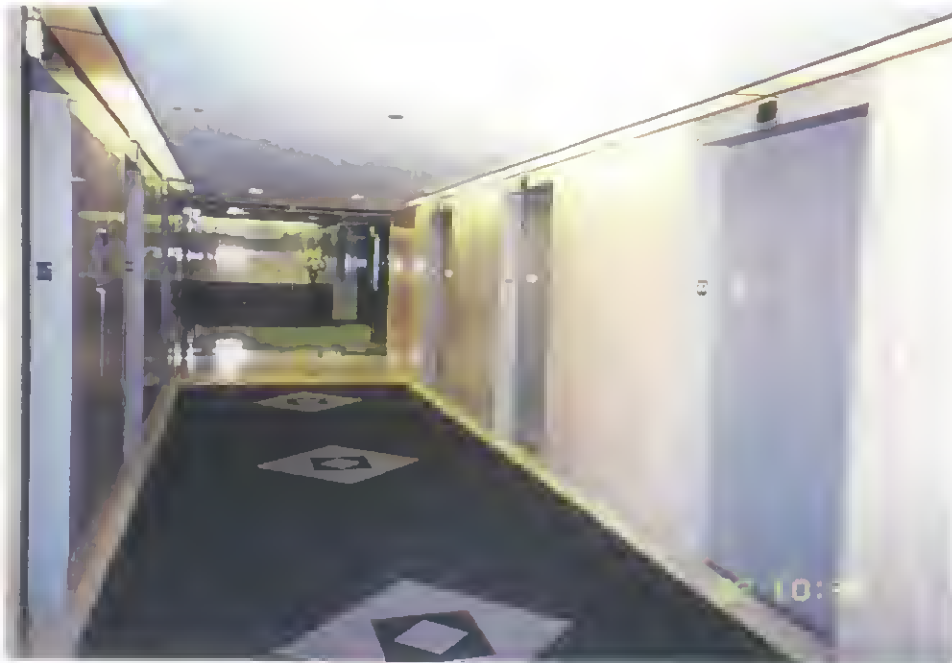
Photograph 17

Typical multi-tenant  
elevator vestibule

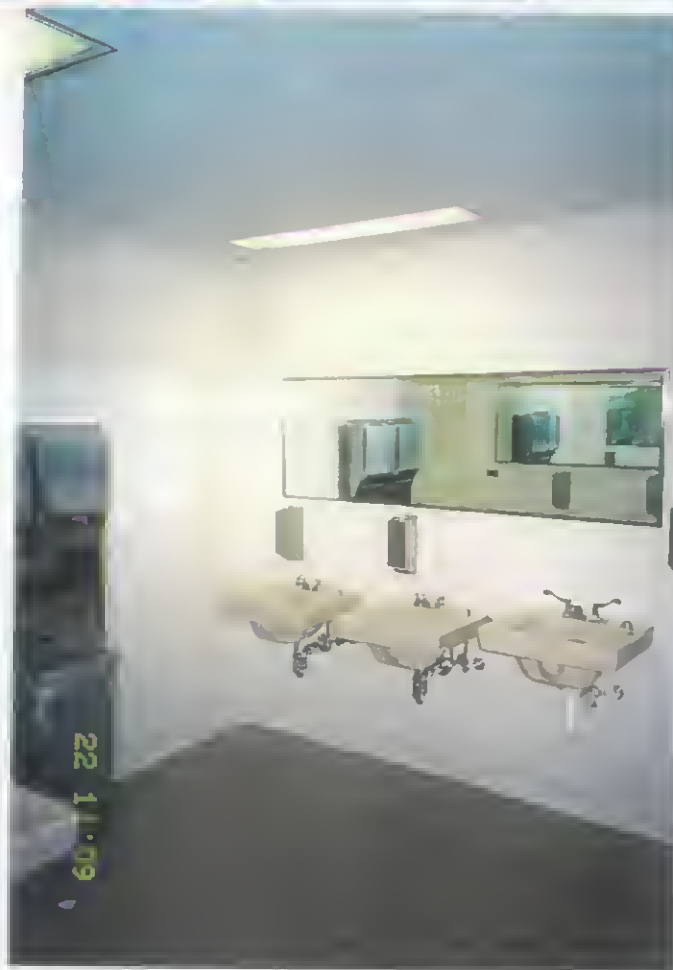
Photograph 18

Typical toilet room  
with original finishes

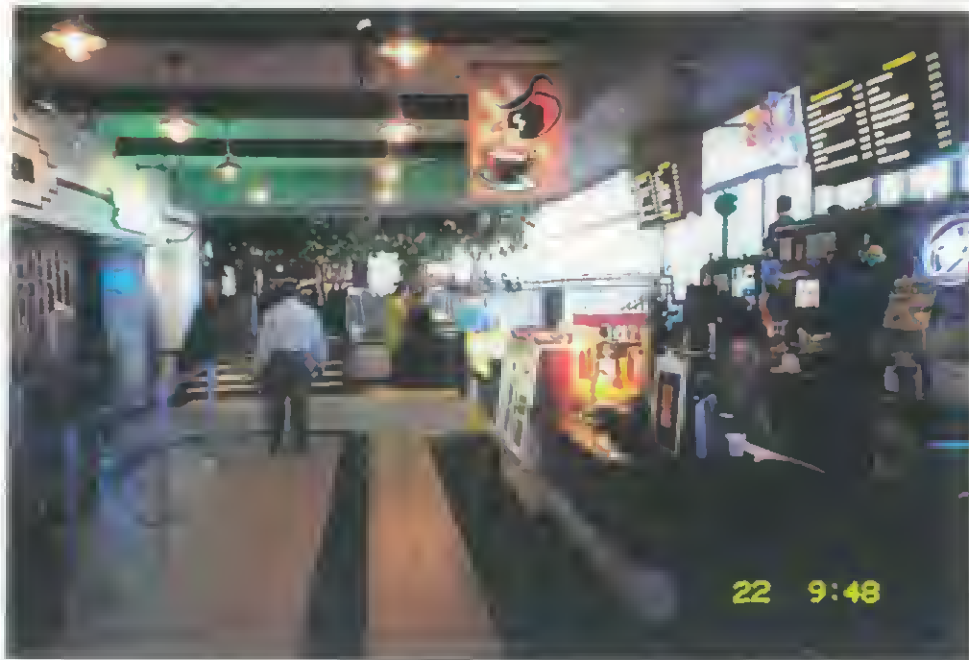
Photograph 19

Observation deck  
cafeteria

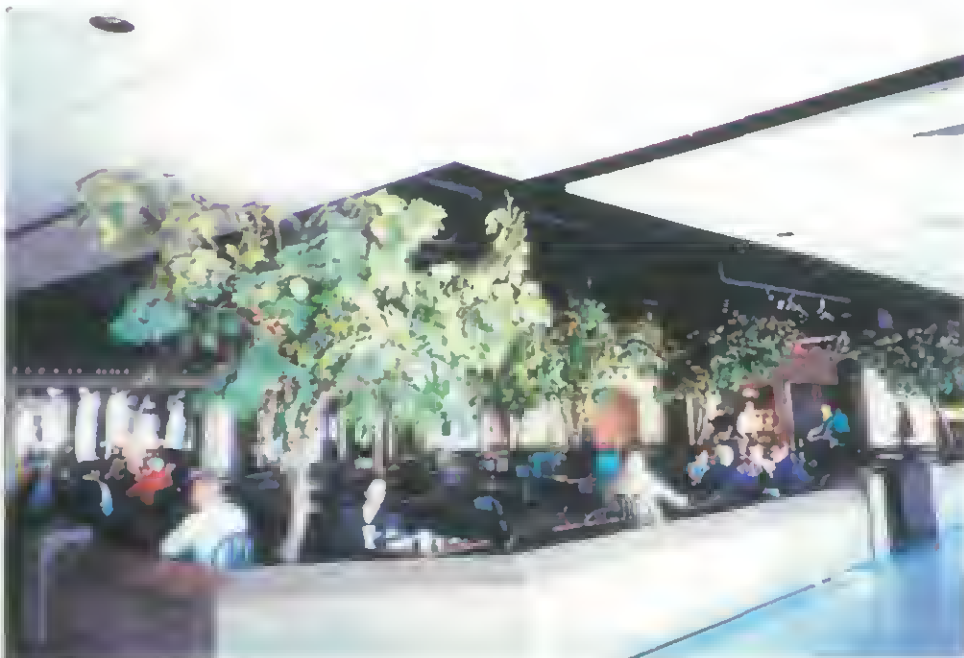
Photograph 20

Observation deck  
eating area
